PRELIMINARY DAMAGE ASSESSMENT ANALYSIS WITH SATELLITE AND DRONE IMAGERY - SAMPLING OF CLASSIFICATION TO SUPPORT EARTHQUAKE AUGUST 14TH 2021, HAITI

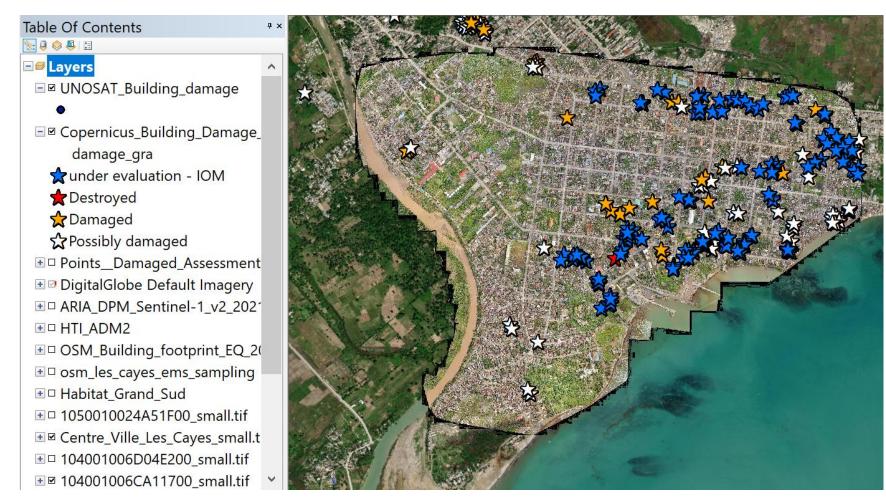
In Les Cayes centre-ville where WB drone imagery overlaps with the satellite imagery from DigitalGlobe, the Copernicus EMS photo-interpretation analysis revealed 66 buildings:

- 2 destroyed (red)
- 21 damaged (orange)
- 43 possibly damaged (white)

In the meantime, the photointerpretation done by IOM added 140 buildings destroyed or high damages (blue color - under evaluation) in the same area based on drone imagery. This interpretation is going to improve the model for machine learning / A.I. recognition which will be loaded in the Picterra platform.

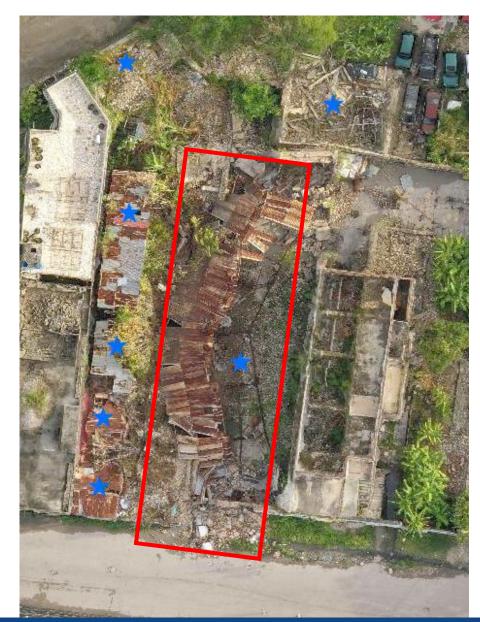
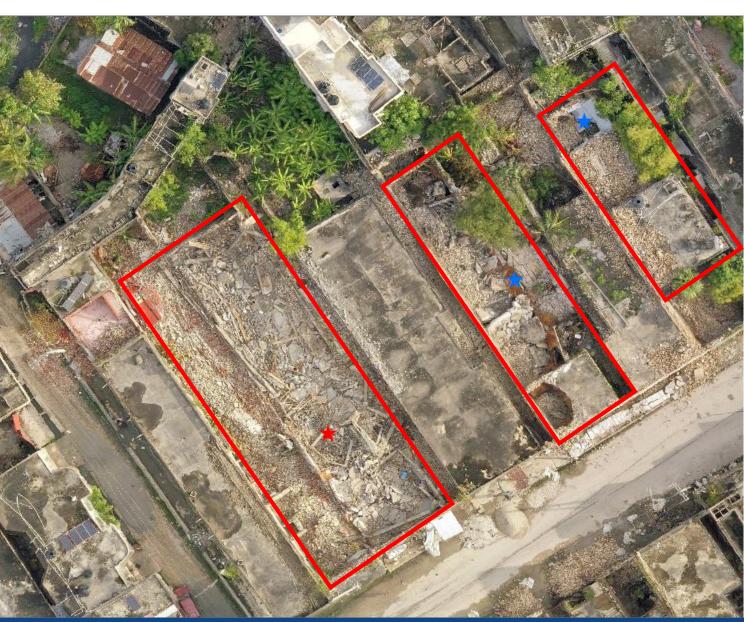
Some sampling of buildings destroyed on drone imagery

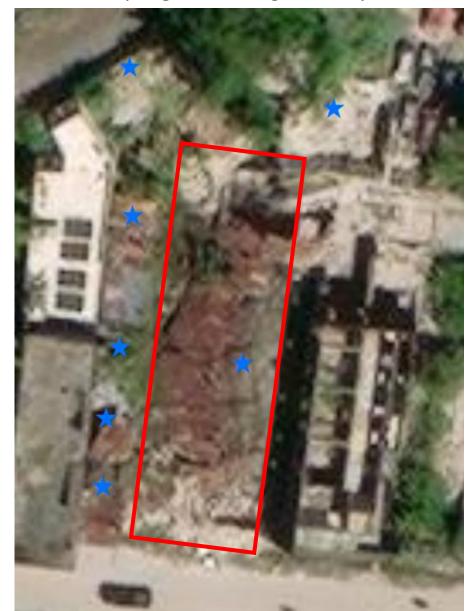
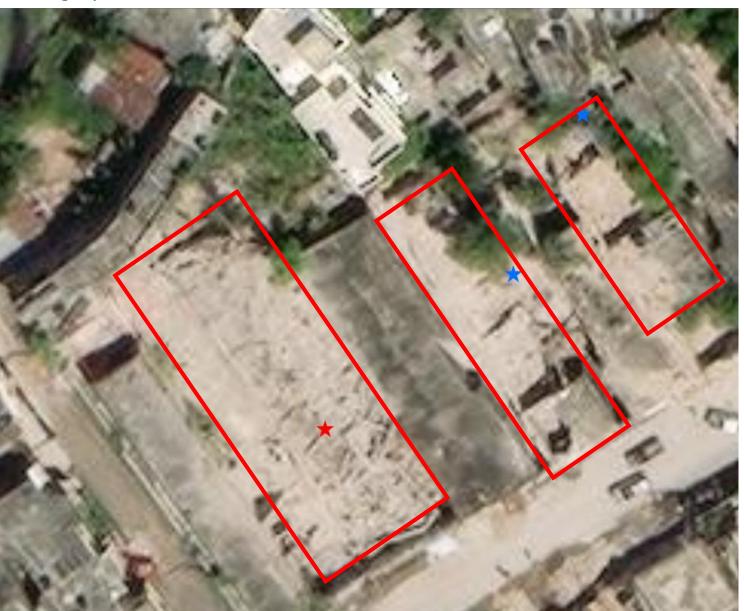
• It is harder to identify those damages in satellites imagery. And geo-referencement is slightly shifted from one image to the other. So polygons need to be done on satellite imagery and duplicated on drone image.

Some sampling of buildings destroyed on satellite imagery

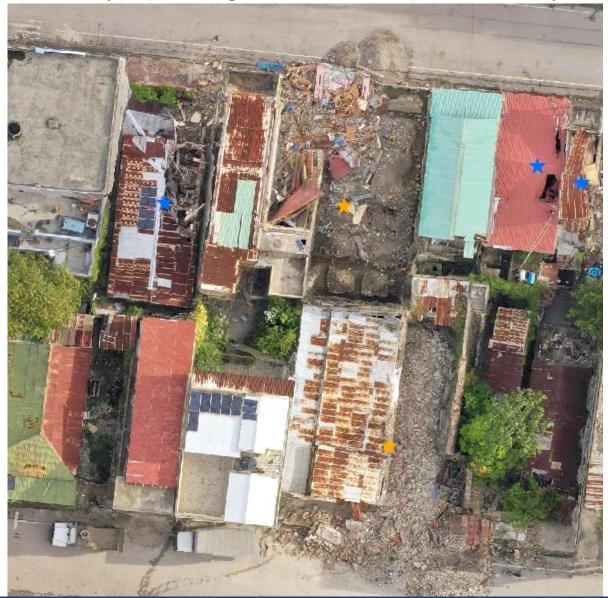
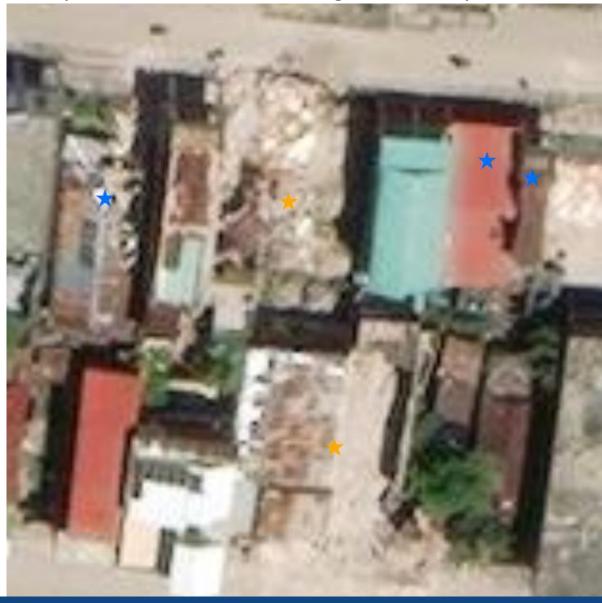
Need to improve the classification of damaged and destroyed for machine learning. Need photo-interpretation to understand if roof collapse (checking amount of debris), and from Copernicus analysis to check whether damaged or destroyed.

Different photo-interpretation from drone and satellite imagery.
