SHELTER/NFI SECTOR, COX'S BAZAR  
SHELTER PERFORMANCE STANDARD ASSESSMENT  
SURVEY ANALYSIS: SEPTEMBER 2022

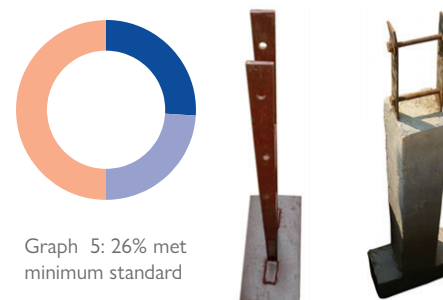
**26%** of shelters met the minimum standard with all footings being concrete or metal. 50% of shelters did not meet the standard by having less than four footings in concrete or metal, and 24% shelters met the standard partially with only four corner columns having concrete or metal footings.

Footings made of concrete or metal to keep bamboo structure out of the ground

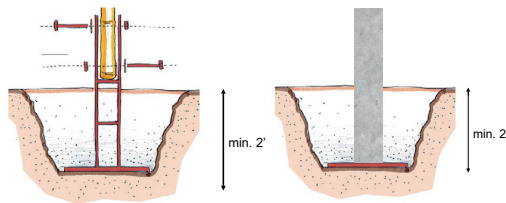
**21%** of shelters met the minimum standard for all **footings/RCC (Reinforced Cement Concrete) posts being 60 cm (2ft.) in the ground**. 57% of shelters did not meet by having less than four footings/RCC posts at the correct depth and 22% shelters met partially with the four corner footings/RCC posts at the correct depth i.e. 2' in the ground.

Left: metal footing 2' under the ground; right: concrete post 2' under the ground

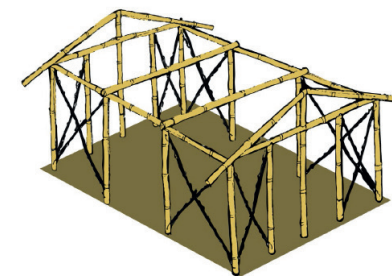
Rope bracing ✓

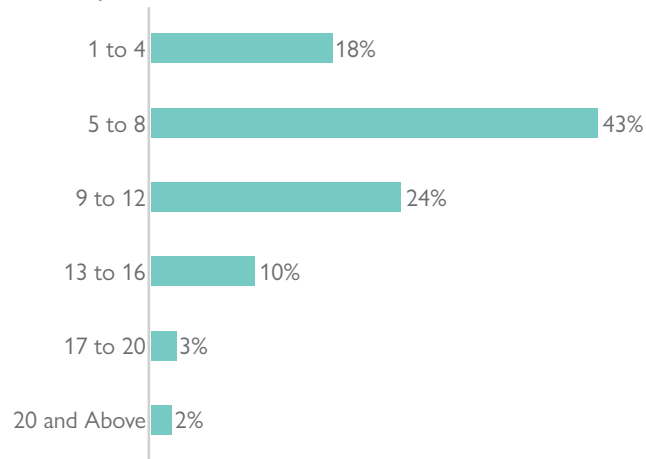
**Graph 16: HHs Reported Structural Bamboo Showing Signs of Infestation**

On average, 8 structural bamboo (borak) members showed signs of infestation. The signs of infestation observed were small holes (45%), big holes (22%) and dust (34%).
