HOUSEHOLD'S PERCEPTION AND USE OF 150 SQ. FEET SHELTERS

(BUILT FOR THE FIRE RESPONSE IN CAMPS 9, 8E AND 8W)

SURVEY ANALYSIS: OCTOBER, 2022

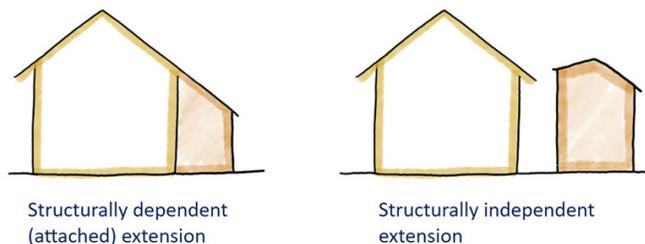
Figure 2: Structurally Dependent and Independent Extensions

98% of the assessed HH's extensions were structurally dependent on the main shelter (attached to main shelter), while 2% of HHs extensions were independent of the main shelter (used for bathing purposes).

Structurally Dependent Extensions:

For the purpose of the survey, it was defined that structurally dependent extensions:

- were structurally adequate if they had two or more borak columns and if those columns were connected with borak beams;
- were structurally partially adequate if they had minimum two borak columns or minimum two muli columns and if those columns were connected with muli beams;
- were structurally inadequate if they did not have any borak bamboo structural members.

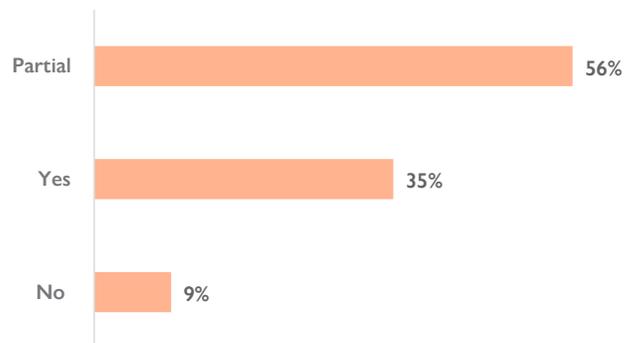
Graph 13: Structural Stability of Extensions

(Graph 13) 35% of the structurally dependent extensions were found to be structurally adequate, 57% were found to be partially adequate, and 9% were found to be structurally inadequate.

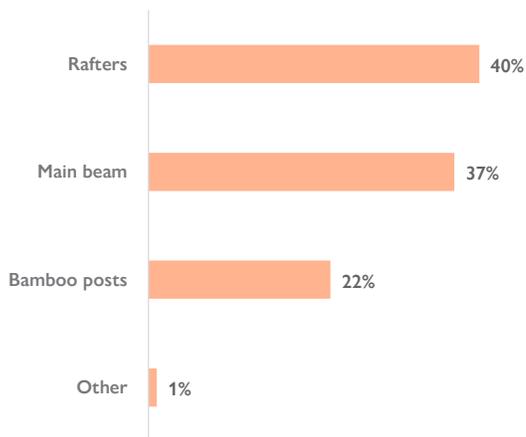
Graph 14: Connection of Extension to the Shelter

(Graph 14) For 77% of dependent extensions, the roofing members were used to connect the shelter extension to the main structure, and in 22% of the cases, the extension was connected with the main shelter's bamboo columns.
