South Sudan

Seasonal floods analysis in Pibor county, Jonglei state

Map production date: 01 November 2019
 Main map scale at: 1:450,000
 Flood data analysis: IOM
 (Preliminary analysis. Need validation from the field.)
 Sensor: Sentinel-1 SAR (Synthetic Aperture Radar) and Sentinel-2
 Software: SNAP
 Sensor date: 06, 12, 18, 24 October and 01 November 2019
 Source data: IOM, OSM

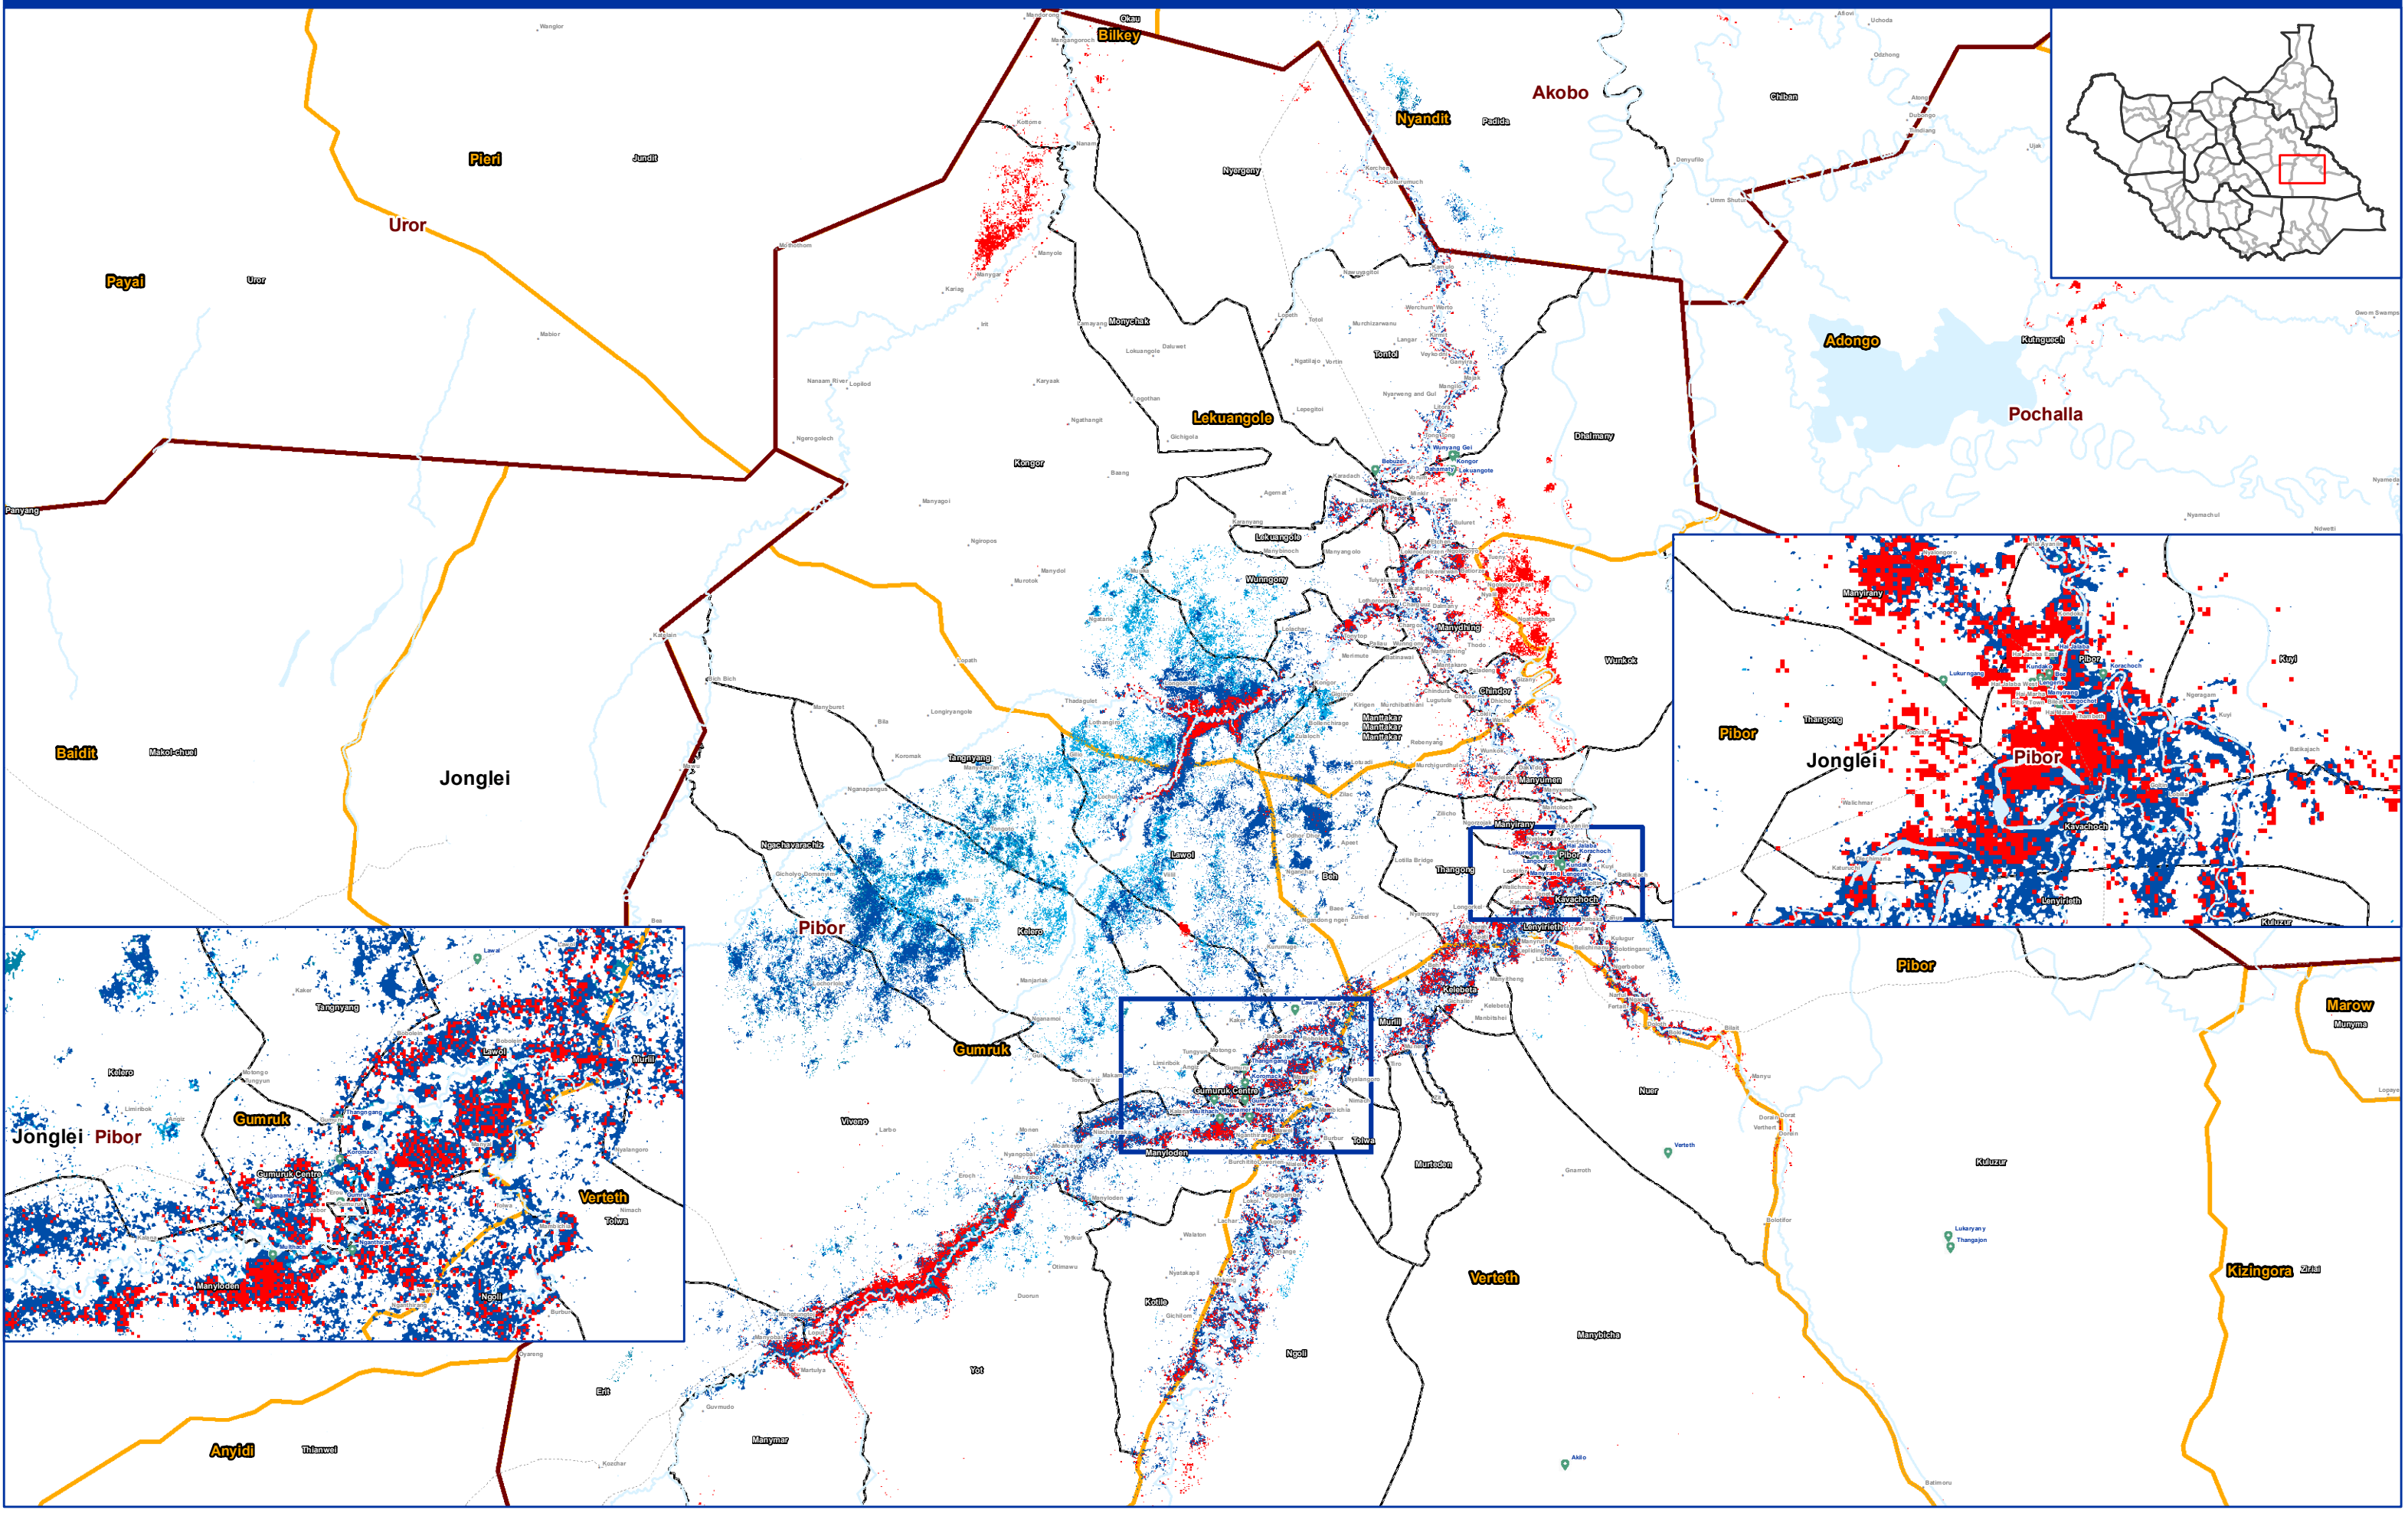
Detected water as of 1st November 2019	 	IDPs in Host Communities - IOM DTM	 	Admin 1 State
 	Detected water as of 18 and 24 October 2019	 	Settlements	 	Admin 2 County
 	Detected water as of 12 October 2019	 	Roads	 	Admin 3 Payam
 	Detected water as of 06 October 2019	 	Waterways	 	Admin 4 Boma
		 	Waterbodies
