PRELIMINARY DAMAGE ASSESSMENT ANALYSIS WITH SATELLITE AND DRONE IMAGERY - SAMPLING OF CLASSIFICATION TO SUPPORT EARTHQUAKE AUGUST 14TH 2021, HAITI

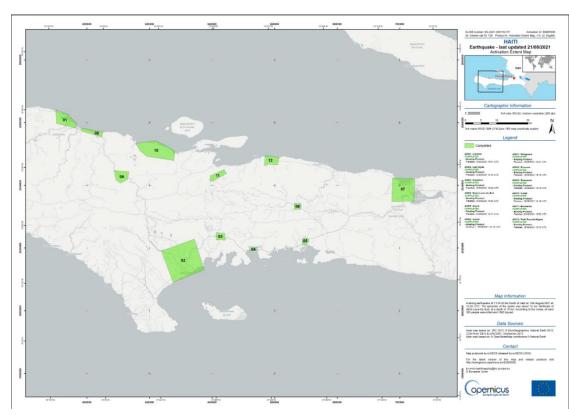
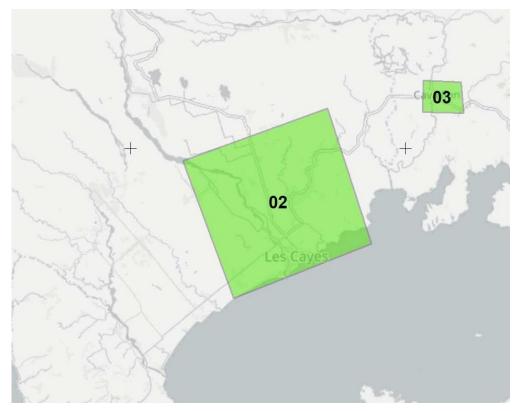
• Les Cayes was used as a test area as numbers from preliminary analysis done by Emergency Mapping Service (EMS) of Copernicus estimated around 200 buildings destroyed / damaged / partially damaged. DGPC numbers estimation in commune of Les Cayes are around 7.000 destroyed and 7.000 damaged.

Copernicus EMS area of analysis in Les Cayes.
