SHELTER/NFI SECTOR, COX'S BAZAR  
SHELTER PERFORMANCE STANDARD ASSESSMENT  
SURVEY ANALYSIS: SEPTEMBER 2022

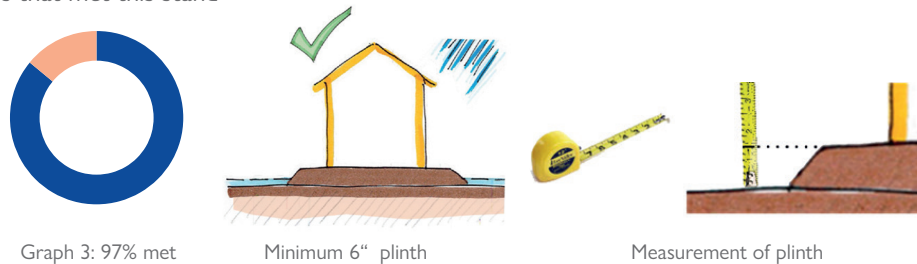
**97%** of shelters had height of plinth above ground level. Further, 86% of total shelters met the minimum standard of plinth above 15 cm (6"). The plinth was measured on all four corners of the shelter and the average value was recorded. The average height of plinth was 7.35 cm reported across overall households.

Camp 17, 21 (96%) had the highest proportion of shelters that met the minimum standard of having plinth above 15 cm (6") ground level and camp 09 (63%) had the lowest proportion of shelters that met this standard.

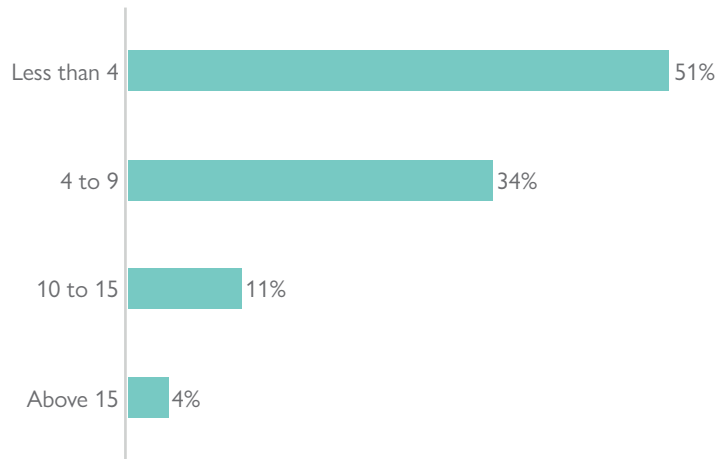
Graph 7: Metal/Concrete Footings 2 ft in the Ground

51% shelters have less than 4 metal footings installed 2' in the ground, while 49% shelters have more than 4 metal footings 2' in the ground.

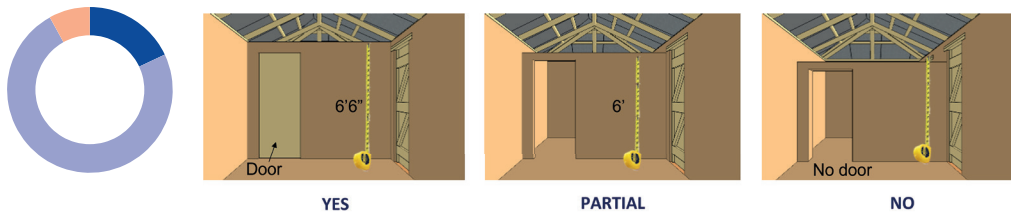
Graph 13: 18% met minimum standard

**18%** of shelters met the minimum standard for at least one internal partition wall to provide privacy (at least 6'6" partition with door). 8% of shelters did not meet the standard (if there is no partition or if the partition is less than 5' with or without door) and 74% shelters met partially (if partition is equal to or more than 6'6" but without a door, or if the partition is between 5' and 6'6" with or without door).

KRC (48%) had the highest proportion of shelters that met the minimum standard for having at least one internal partition and camp 17 (1%) had the lowest proportion that met this standard.

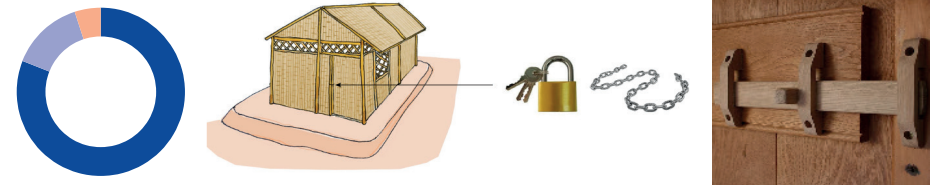
Graph 14: 81% met minimum standard

**81%** of shelters met the minimum standard **to be lockable from inside and outside using a padlock and chain.** 5% of shelters did not meet the standard by not having shelter lockable from inside and outside and 14% shelters met the standard partially by having shelter lockable only from the inside with a latch.

Camp 4Ext (98%) had the highest proportion of shelters that met the minimum standard for the shelters to be lockable from inside and outside and camp 6 (54%) had the lowest proportion that met this standard.

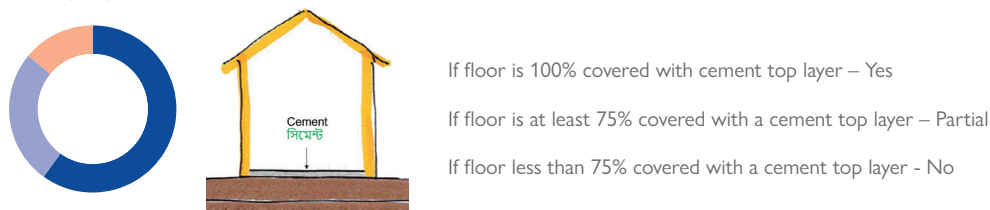
Graph 17: 60% met minimum standard

**60%** of shelters met the minimum standard of having a floor with a top layer finished with cement that does not have holes or excessive damage. 14% of shelters did not meet the standard with less than 3/4th of the floor with a cement top layer. 26% of shelters met the standard partially (some parts of floor are finished/floor are finished with a top layer of cement but there are small holes).

Camp 4 Ext (97%) had the highest proportion of shelters that met the minimum standard for having cement floor finishing without holes or excessive damage and camp 21 (28%) had the lowest proportion that met this standard.

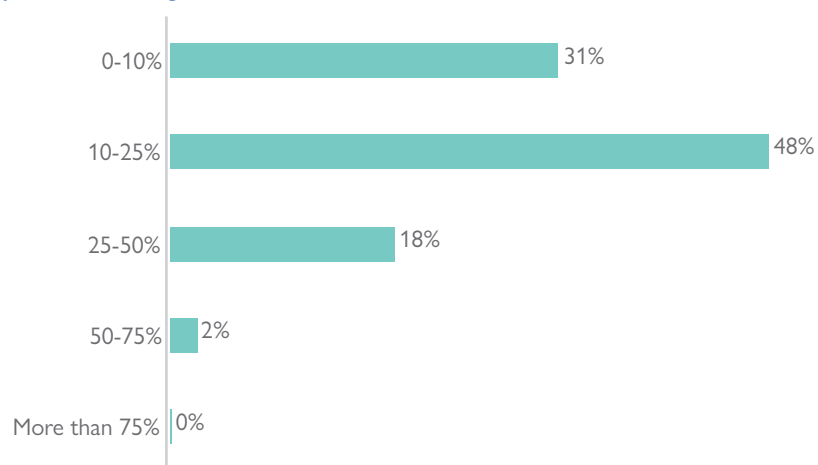
Graph 20: Percentage of the Surface of the Roof Area where the Roof Leaks

Out of those shelters where rain water seeped through the roof, a significant area of leakage, 51-75% was reported by only 2% HHs whose roof leaked and almost half (48%) of the respondents faced smaller roof surface area leakage (11- 25%).

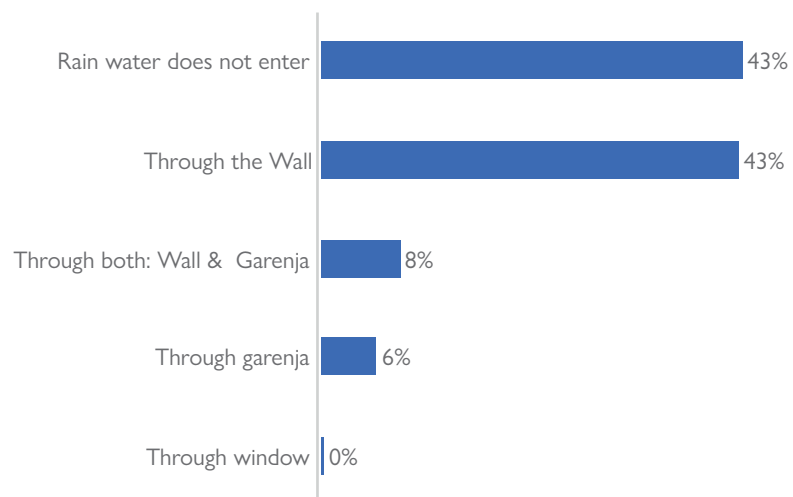
Graph 21: HHs Reported Different Ways Rain Water Enter to the Shelter

43% HH reported that rain water does not enter their shelter through the wall at all, and 57% HHs reported rain water entering through the wall. Out of those HHs that reported leakage through the wall surface, 76% had leakage through the wall surface alone. 14% HHs shelters faced leakage through both wall and garenja, and 10% faced leakage through the garenja alone. Five HHs reported faced leakage through the windows.

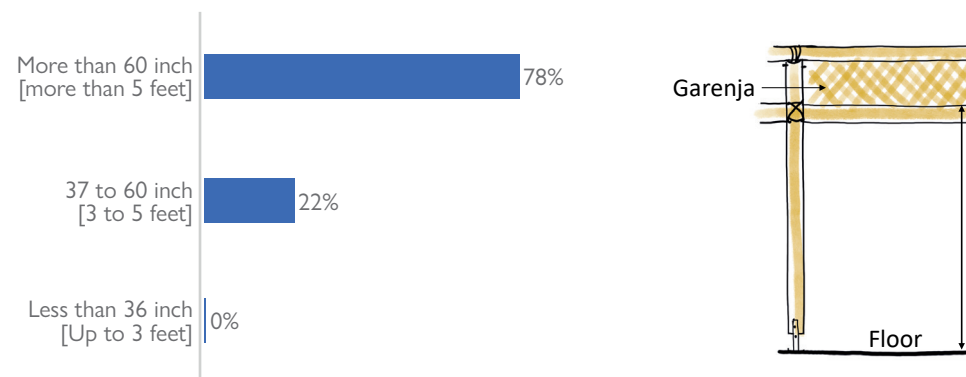
**Graph 26: Height from the Plinth Level where Garenja Starts**

78% of shelters had garenja starting more than 5 feet above plinth level, while 22% had garenjas starting at a height between 3 and 5 feet from plinth level. The SNFI Sector recommends that the garenja should start at least 5 feet above plinth level and the height of the garenja should be 8 to 10 inches.

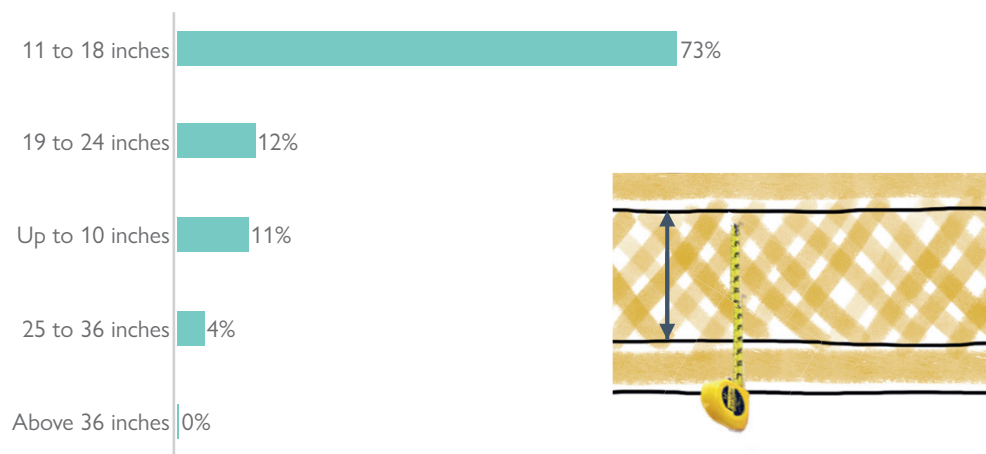
**Graph 27: Height of the Garenja**

The average height of garenja from the assessment was found to be 15 inches, which is 5 inches higher than the standard recommended by the SNFI Sector.

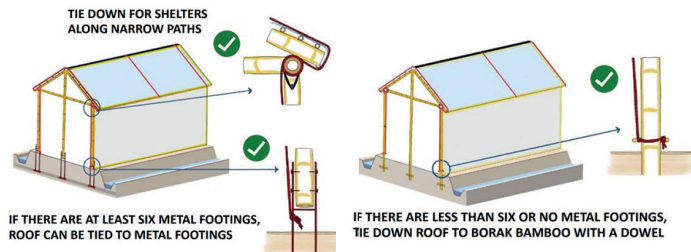
Graph 30: 8% met minimum standard

From the 92% of respondents who did not meet the standards for tying down of roofs or met them partially, 51% stated that the materials for tying down roofs was insufficient, 15% said the ropes were damaged by a passerby, and 12% did not know the reason, 9% did not think it was required to tie down shelter roofs, 4% said their materials were stolen, 2% received no technical support, and 1% stated the slope next to their shelter was too steep to tie down shelters. Other reasons included having damaged rope and damaged anchors.

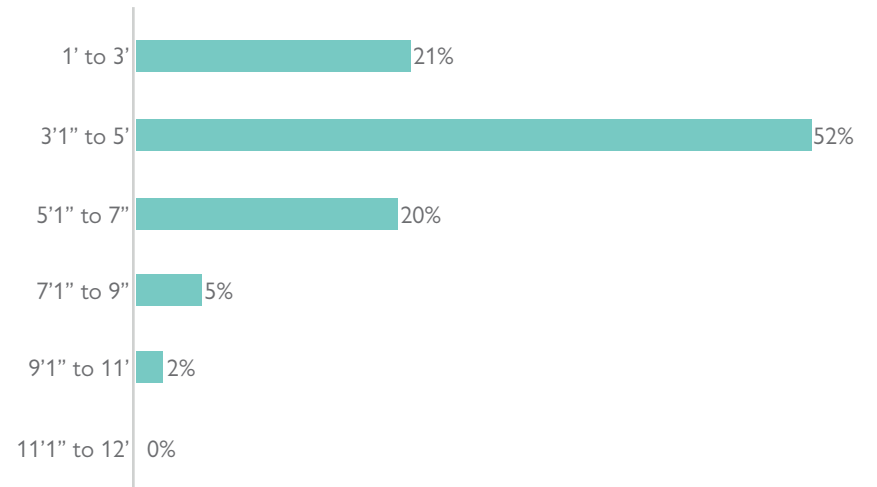
**Graph 35: HHs Had Pathway vs Pathway Width**

The pathways on the remaining three sides of the shelters were measured (only for pathways within 10' distance) and the average was found to be 5'1". The minimum shelter performance standard is that the minor pathways (pathways alongside shelters) should be at least 7' wide. The assessment showed that the average width of pathways on all four sides of the shelters was found to be 4'6". Camp 7 and KRC had the lowest average width of pathways (4'3") and camp 4Ext. had the highest average width of pathways (9'2").
